REPORT OF FLOOD
14-16 MARCH 1978
CHAGRIN AND GRAND RIVERS
OHIO

U.S. ARMY ENGINEER DISTRICT, BUFFALO
JUNE 1978

REPORT OF FLOOD 14-16 MARCH 1978
CHAGRIN RIVER BASIN
STAGE HYDROGRAPHS

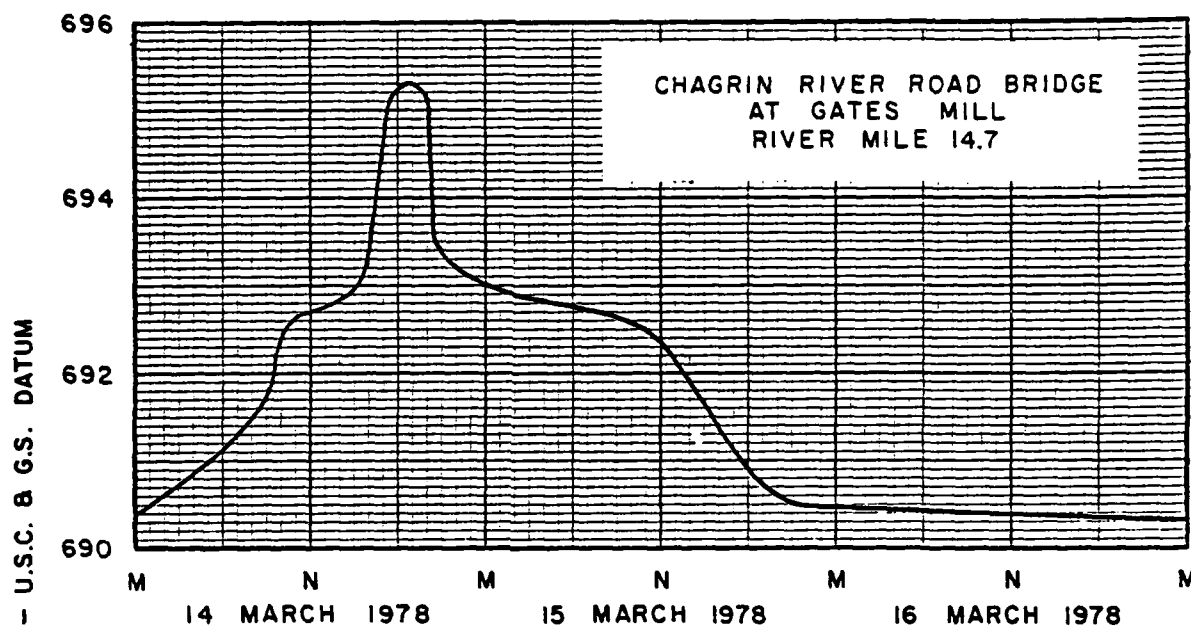
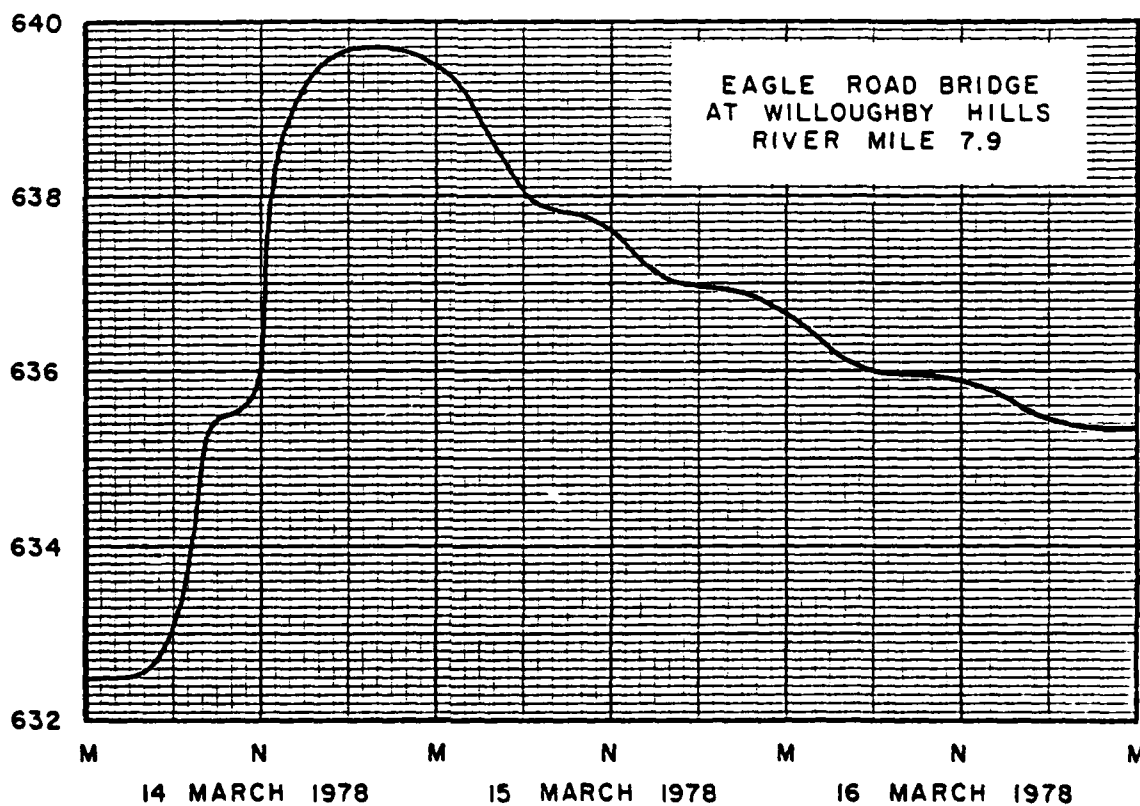
1. STAGES AFFECTED BY ICE JAMS.
2. M DENOTES MIDNIGHT.
3. N DENOTES NOON.

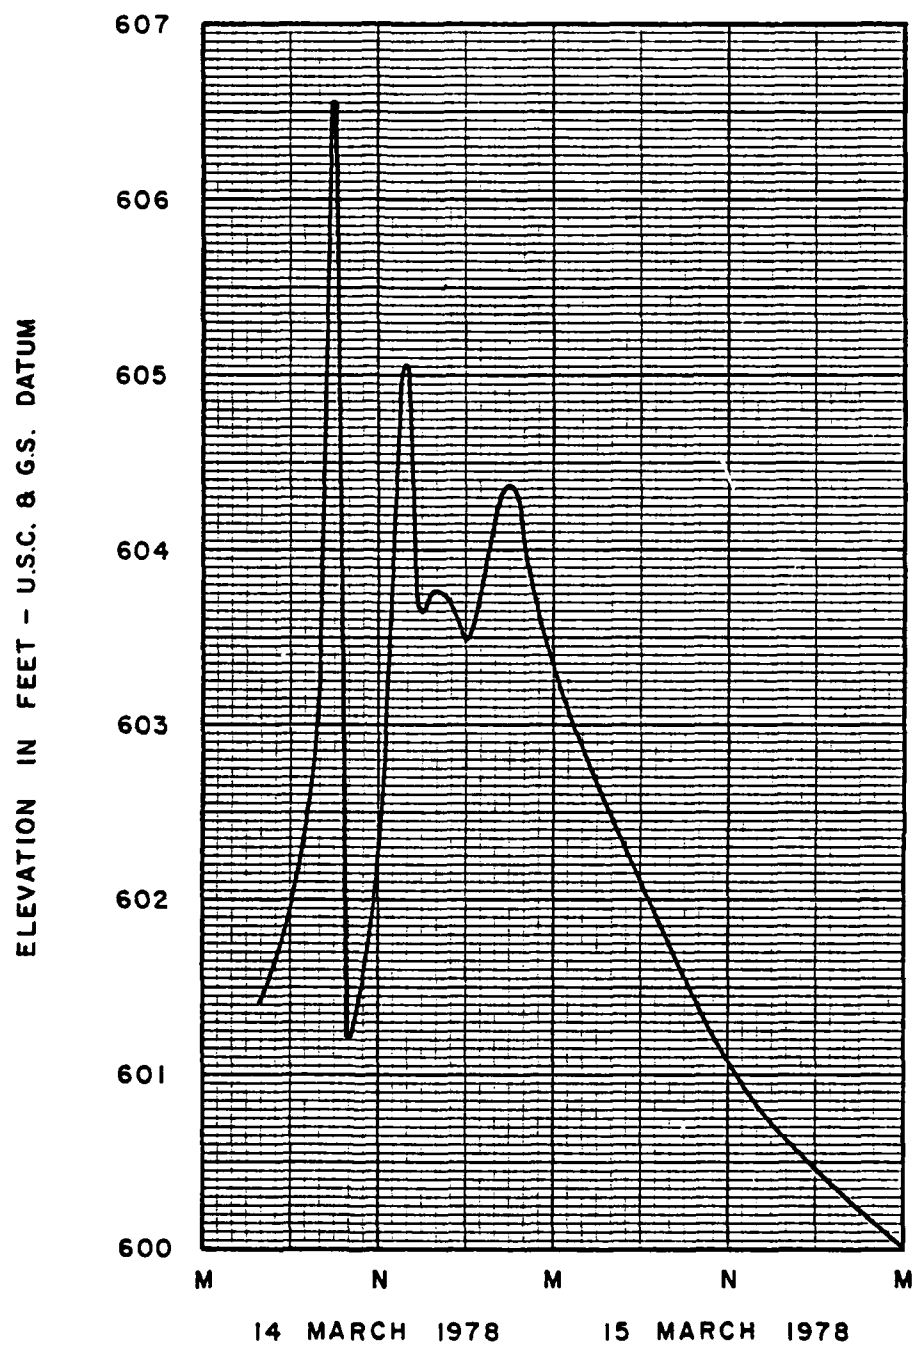
1. ZERO OF GAGE IS EL. 594.57
U.S.C. & G.S. DATUM.
2. DRAINAGE AREA IS 246 SQUARE
MILES.
3. STAGE AFFECTED BY ICE JAMS.
4. M DENOTES MIDNIGHT.
5. N DENOTES NOON.

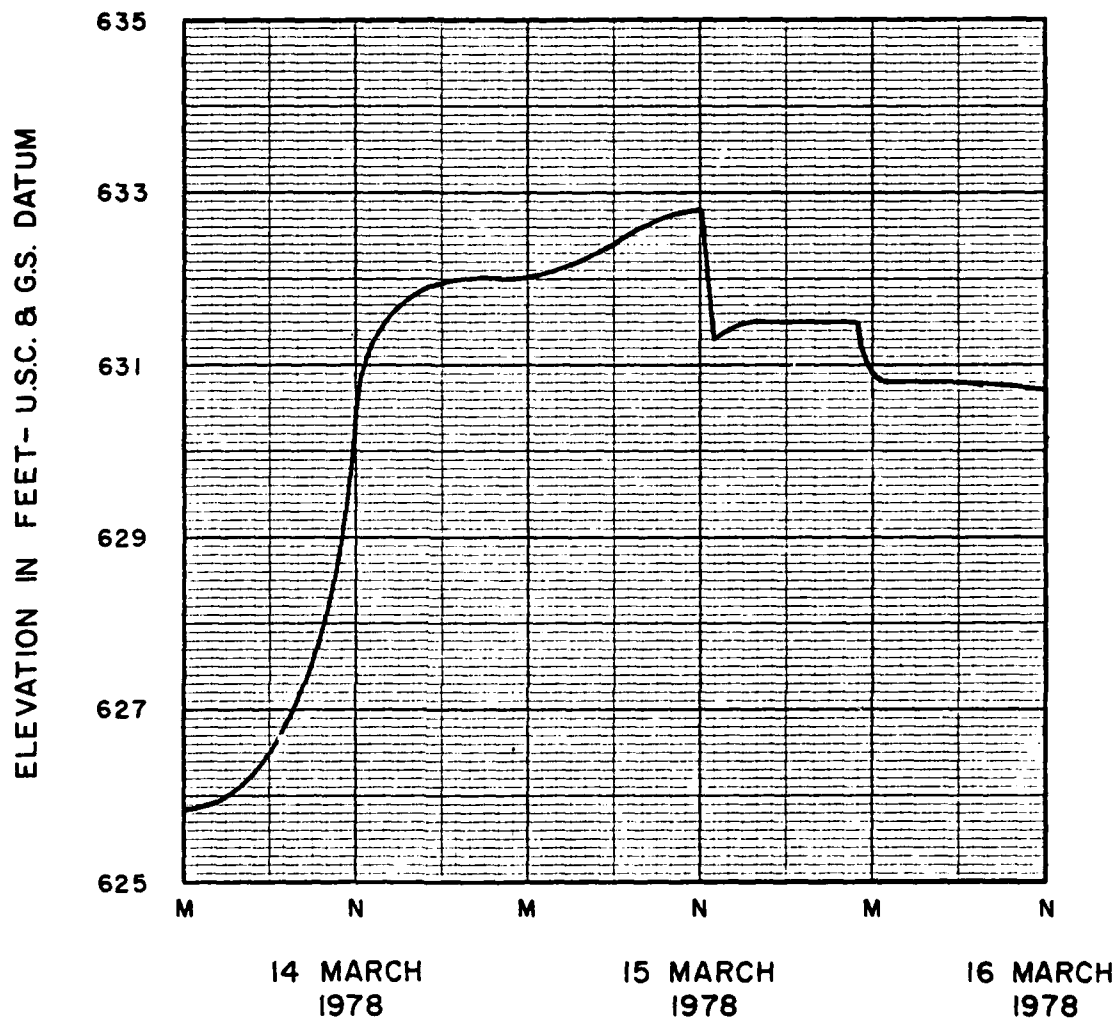
1. ZERO OF GAGE IS EL. 620.37 U.S.C.&G.S. DATUM.
2. DRAINAGE AREA IS 701 SQUARE MILES.
3. STAGE AFFECTED BY ICE JAMS.
4. M DENOTES MIDNIGHT.
5. N DENOTES NOON.
